MEMO

To:	City of Lake Quivira Attn: Angela Gupta 10 Crescent Boulevard Lake Quivira, KS 66217
From:	Brent Johnson, PE Brian Fairchild, PE, CFM Ethan Price, EIT
RE:	5535 Renner Road Sediment Analysis & Field Walkthrough
Date:	May 15, 2023
Project #:	023-00917
Phase:	200
Task:	001

**Lake Quivira
Erosion Analysis Site Visit
Photo Locations and Desktop Analysis**

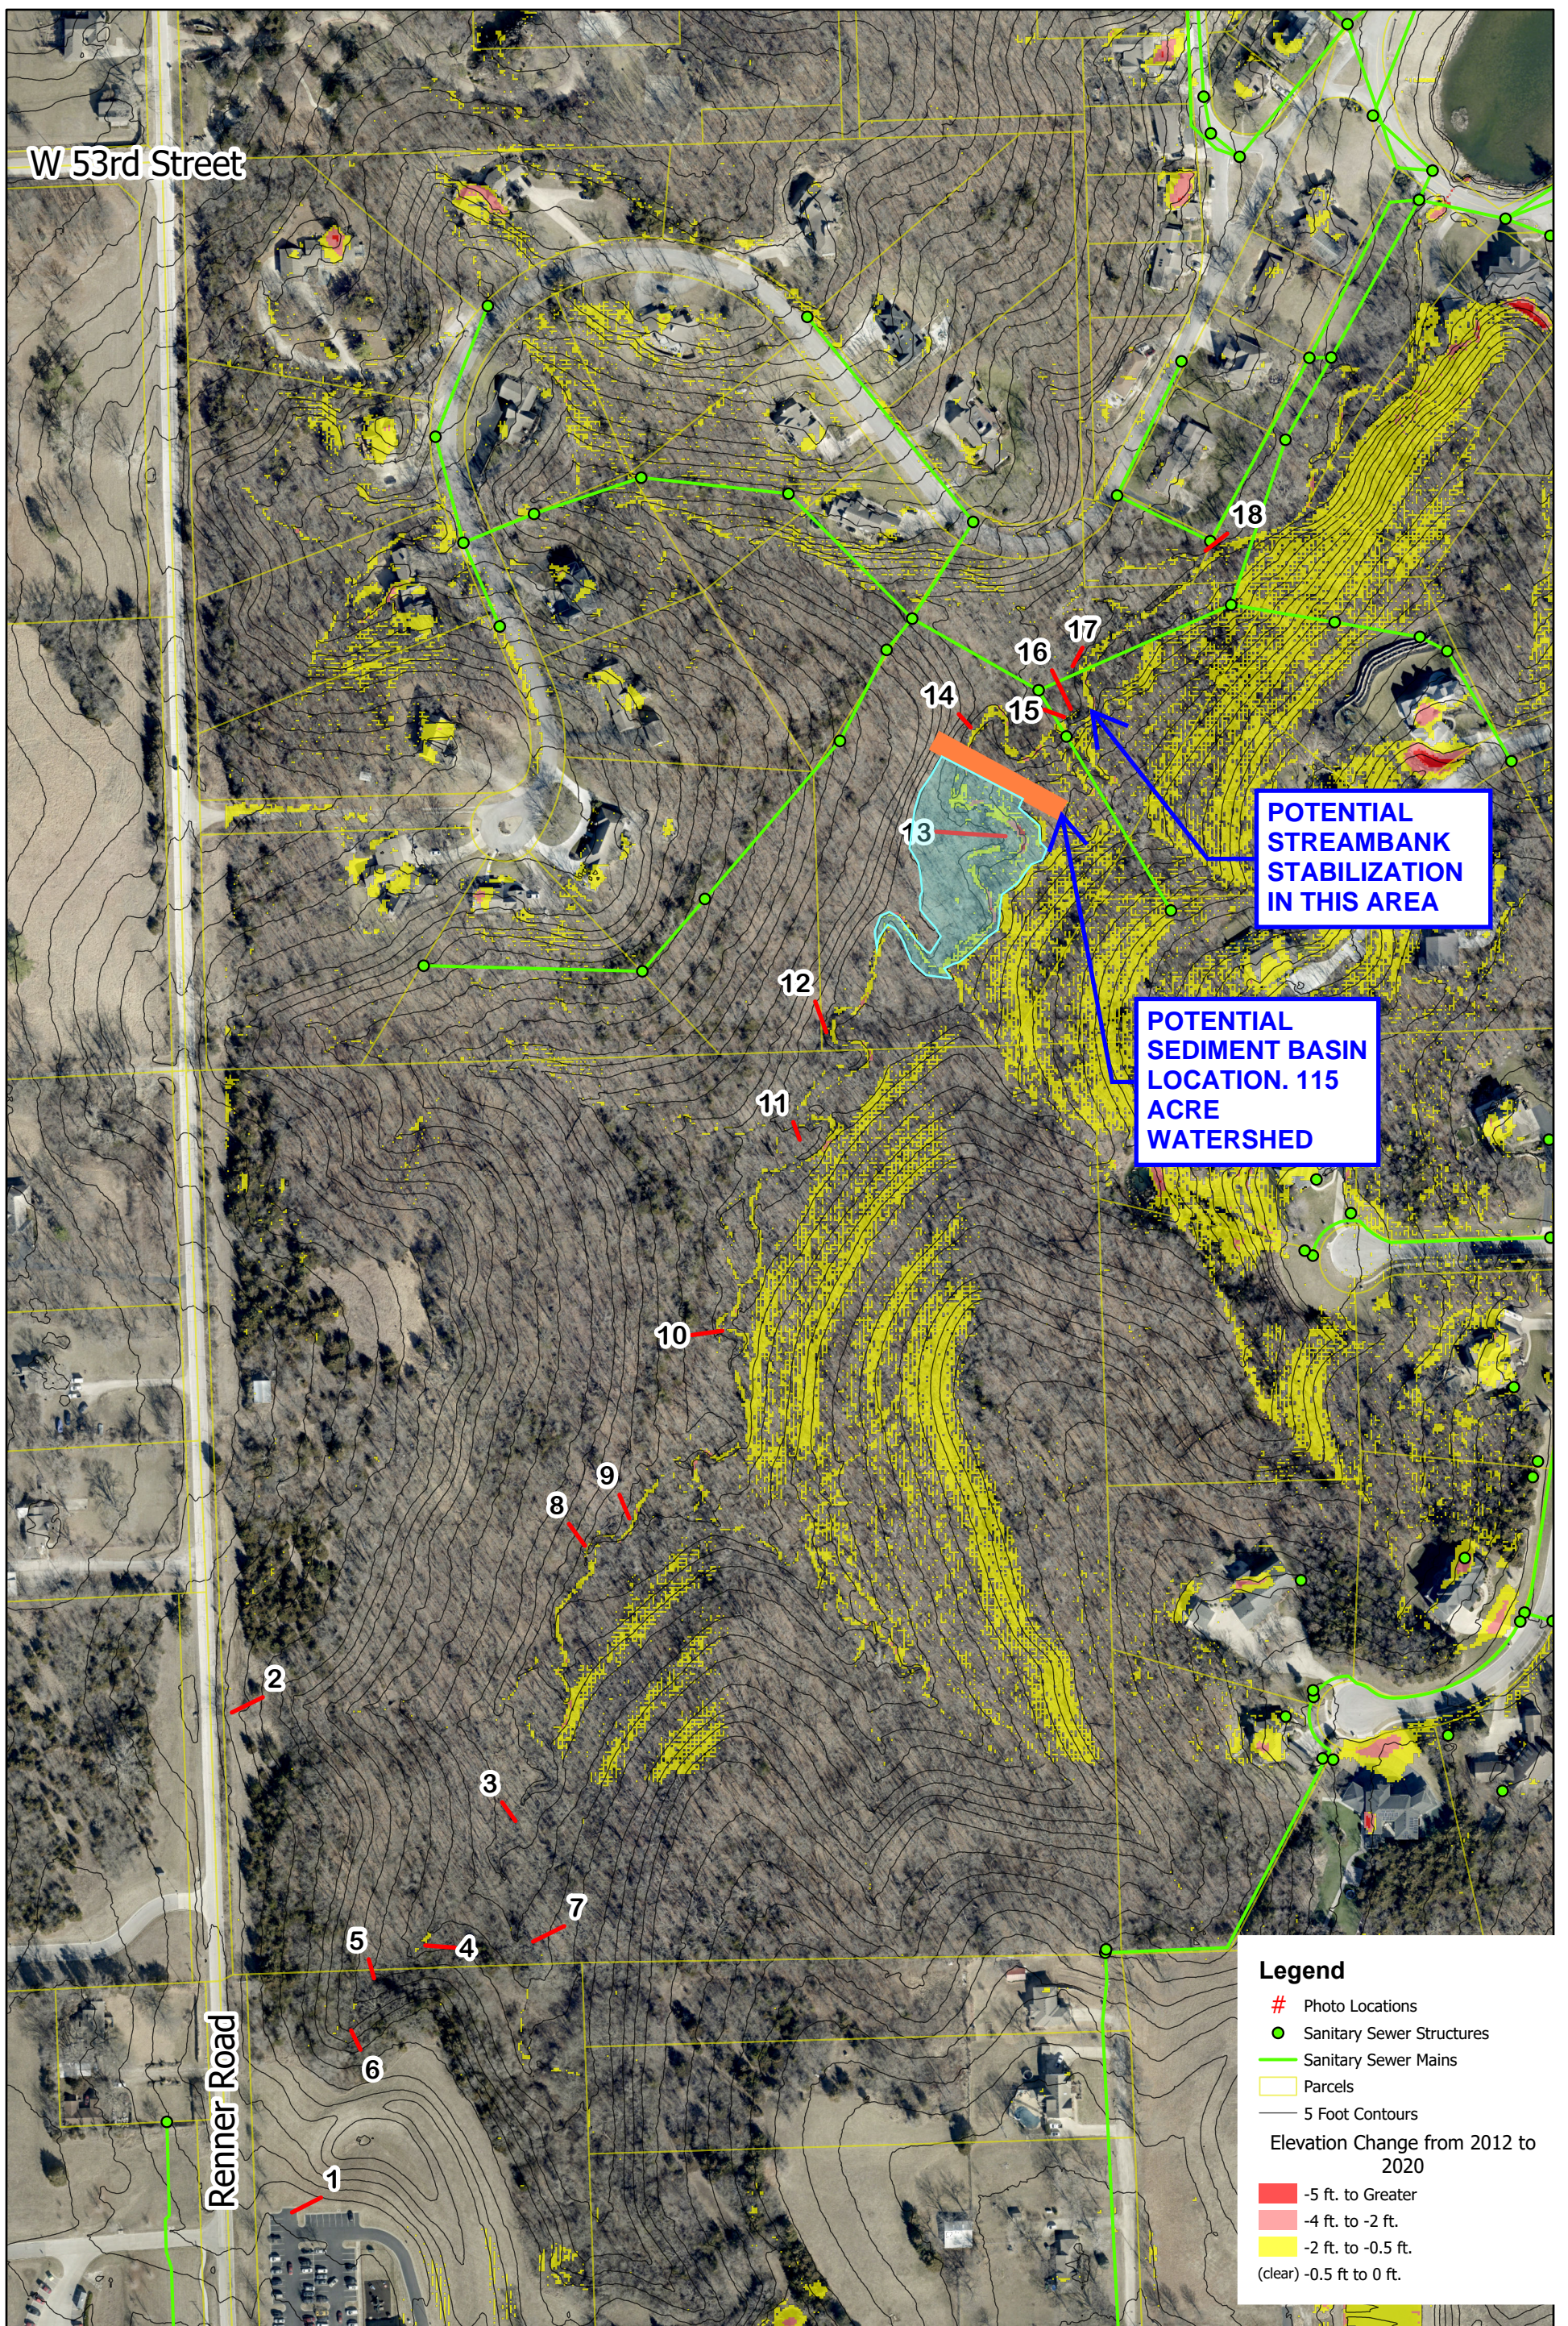
**POTENTIAL
STREAMBANK
STABILIZATION
IN THIS AREA**

**POTENTIAL
SEDIMENT BASIN
LOCATION. 115
ACRE
WATERSHED**

The included photo location map shows concept level recommendations that would mitigate the amount of sediment being delivered to Lake Quivira, based on the findings from the desktop analysis and field walkthrough. A temporary sediment basin behind the property at 445 Navajo Lane West Street would capture sediment from the upstream watershed and provide a short and convenient access point from Navajo Lane West Street for maintenance. Should this option be pursued, a hydrologic and hydraulic analysis would be required to ensure that the sediment basin does not increase flood risk to the surrounding properties. The size of the basin would also need to be engineered to ensure that the basin does not fill with sediment too rapidly, creating overly burdensome maintenance. Maintenance will be required to clean out the basin on a regular basis.

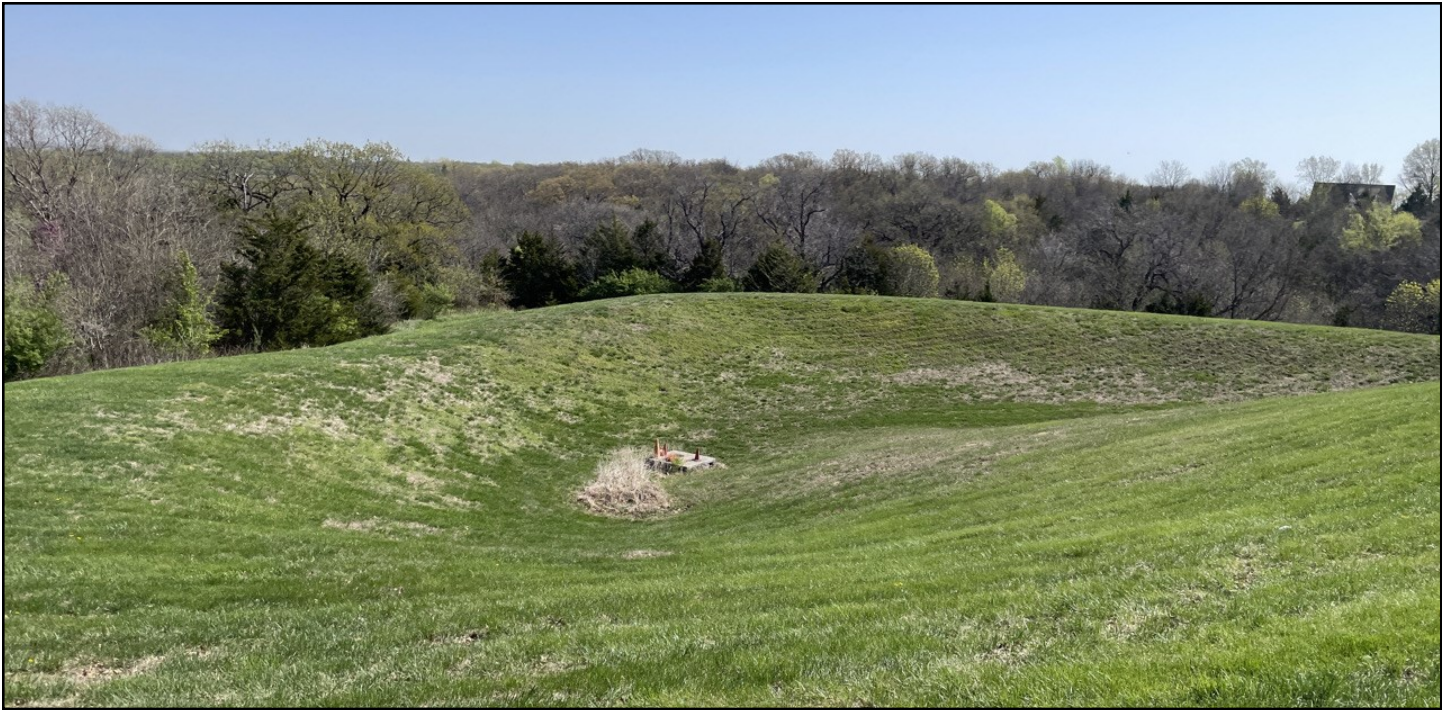
Photo No.	1	Photo Dir.	Northeast
-----------	---	------------	-----------

Description: Detention basin south of the 5535 Renner Road property.

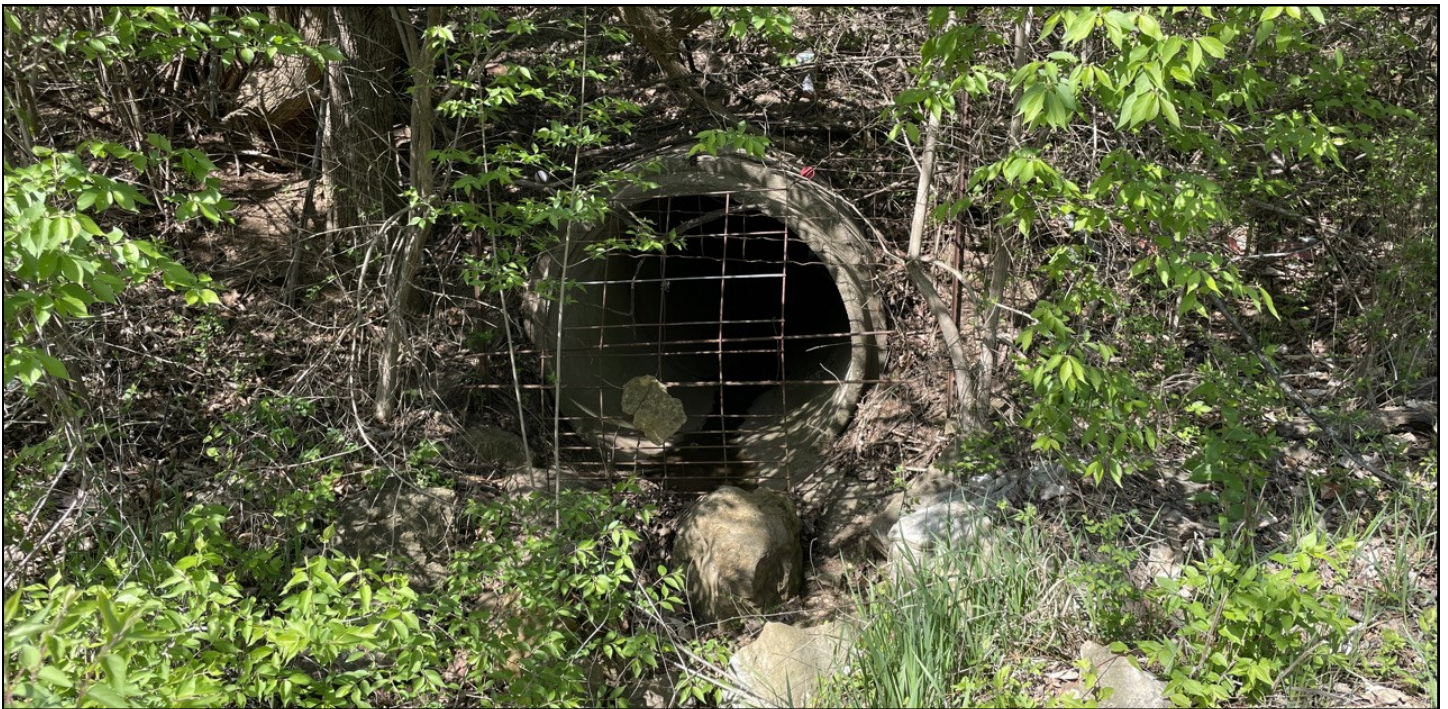
Photo No.	2	Photo Dir.	West
-----------	---	------------	------

Description: Downstream end of storm sewer pipe under Renner road. Drains onto property.

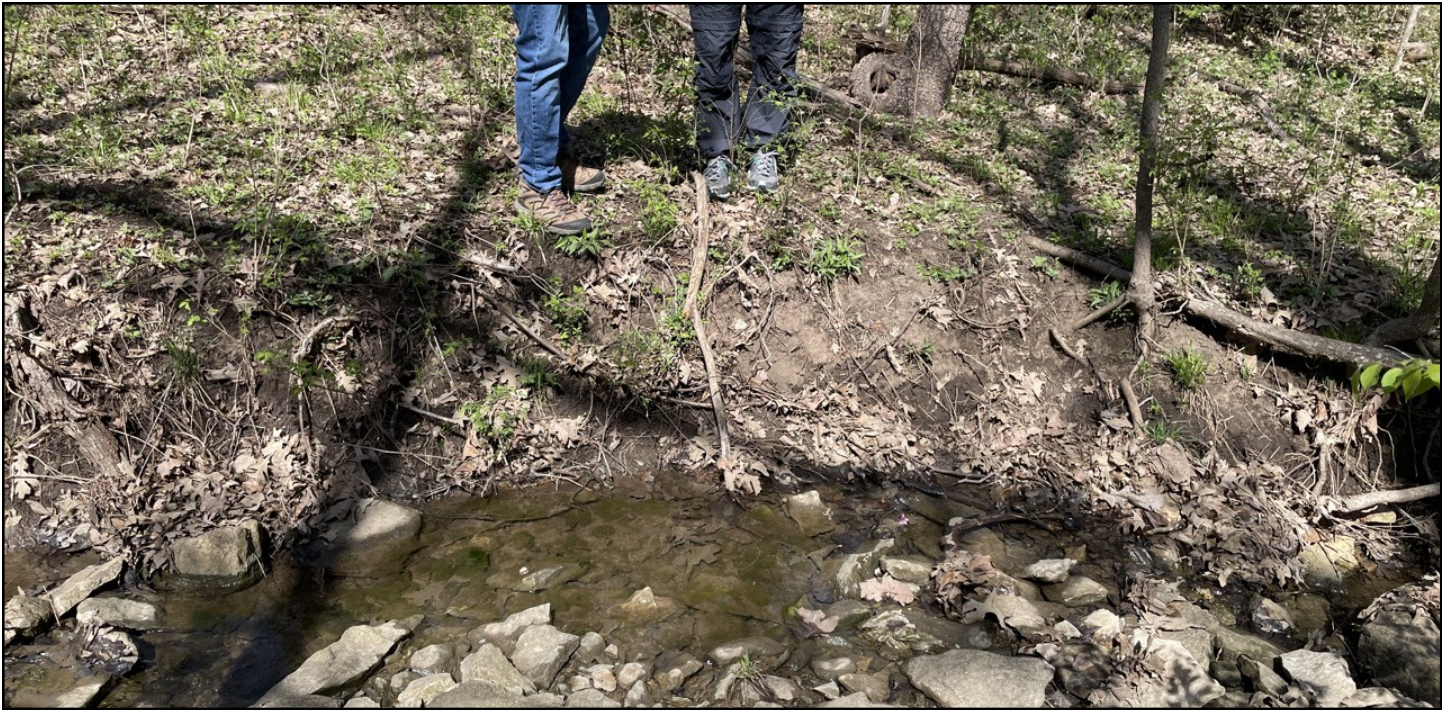
Description: Minor bank erosion present along west bank. Stream bank is approximately 3 feet tall.

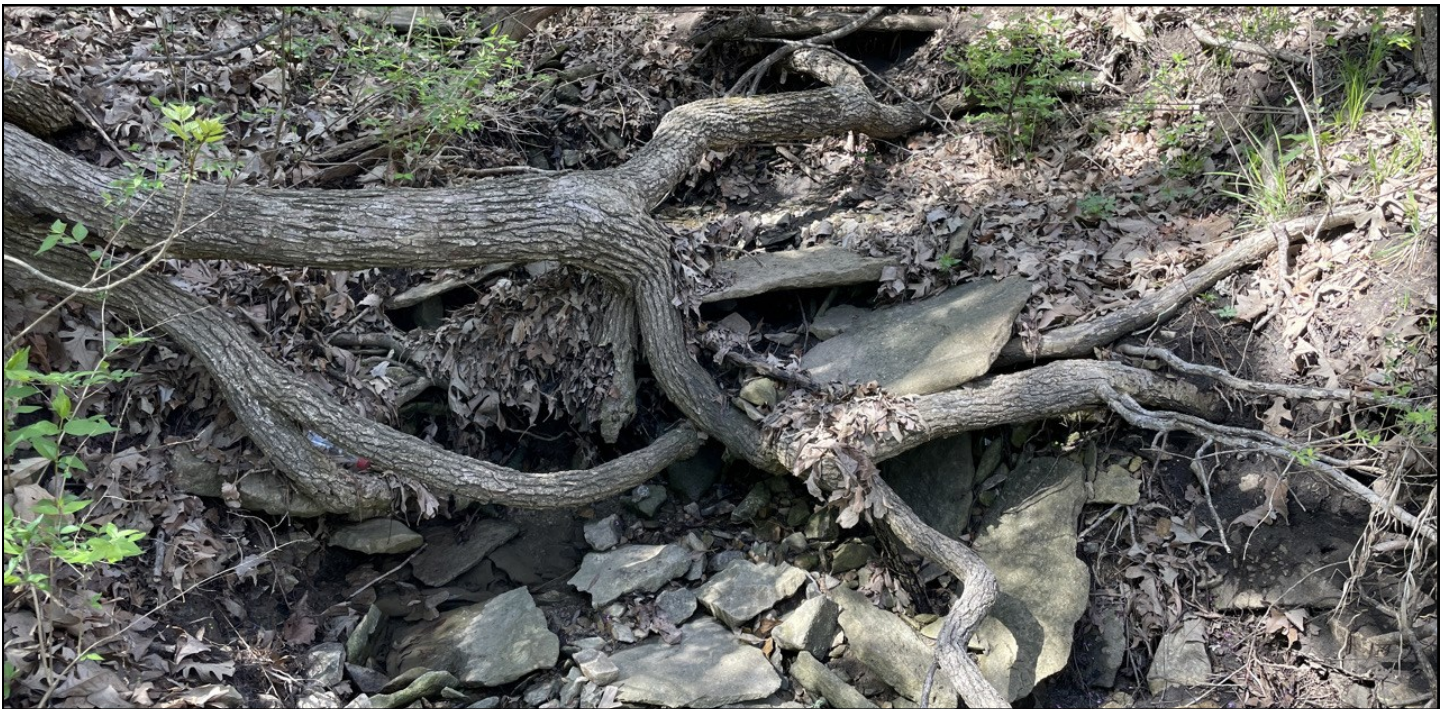
Erosion was also identified along the primary stream corridor, ranging from 0.5 feet to about 6 feet. The headcut identified at photo location 4 was corroborated with the desktop analysis, which indicates that this headcut has been worsening over the past 8 years. Additionally, the scour/erosion identified at photo locations 13, 14, and 16 were also identified in the desktop analysis. These could potentially be good locations to consider sediment mitigation measures, such as streambank stabilization or grade control structures, which will slow or prevent these types of erosion.

Description: Head cut present at upstream end of property. Tree with exposed roots and minor bank erosion present.

As mentioned earlier, a grade control structure could also be installed at photo location 4, which would help prevent the loss of sediment from the stream bottom (i.e., the headcut) from worsening and moving upstream. A grade control structure for this application typically involves digging a trench and filling it with riprap immediately upstream of the existing head cut and functions by preventing the headcut from

continuing its progression upstream. However, given that the headcut erosion is relatively minor in volume compared to the streambanks, it may not be worth the cost of addressing the issue. Furthermore, it is in a different location than the previous two proposed conceptual improvements, hence a contractor would have to clear additional vegetation to reach it.

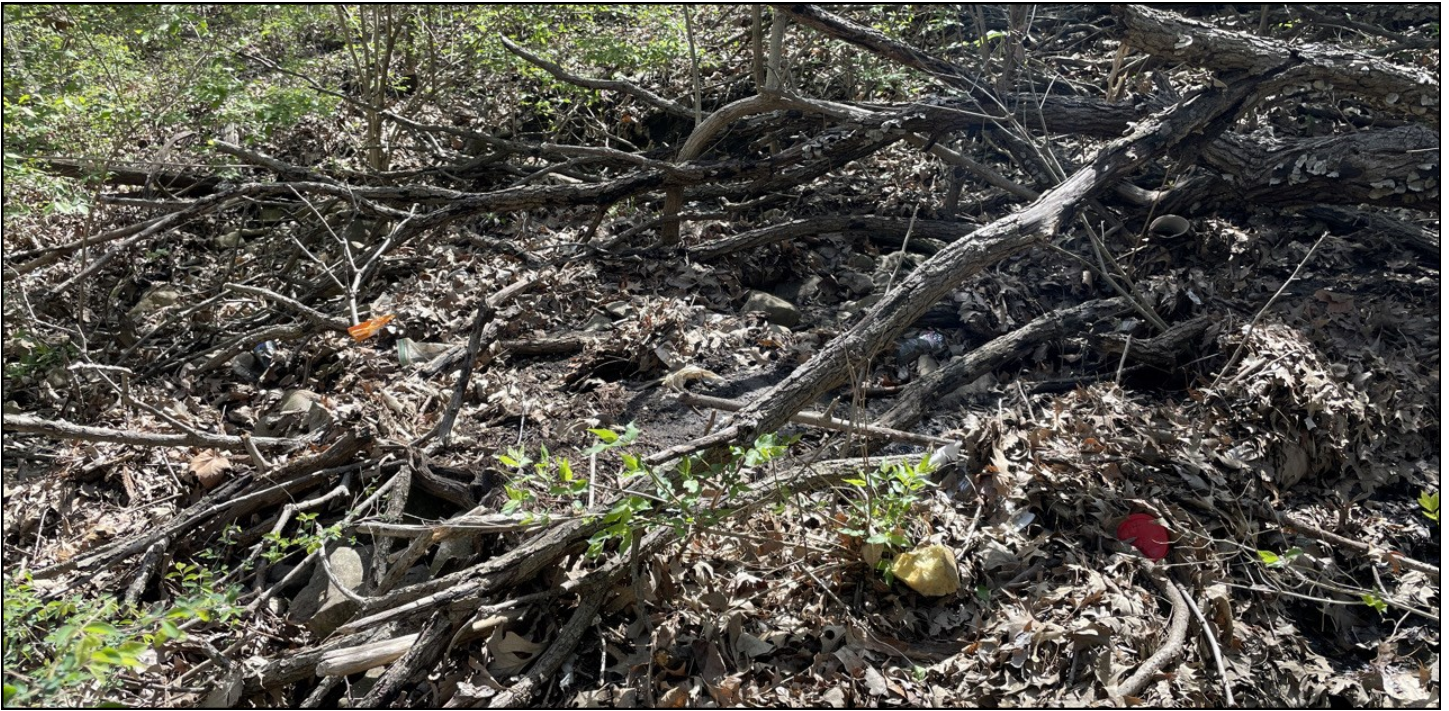
Photo No.	5	Photo Dir.	N/A
-----------	---	------------	-----

Description: 21.2 — Accumulated trash is present along the stream throughout upstream end of the property.

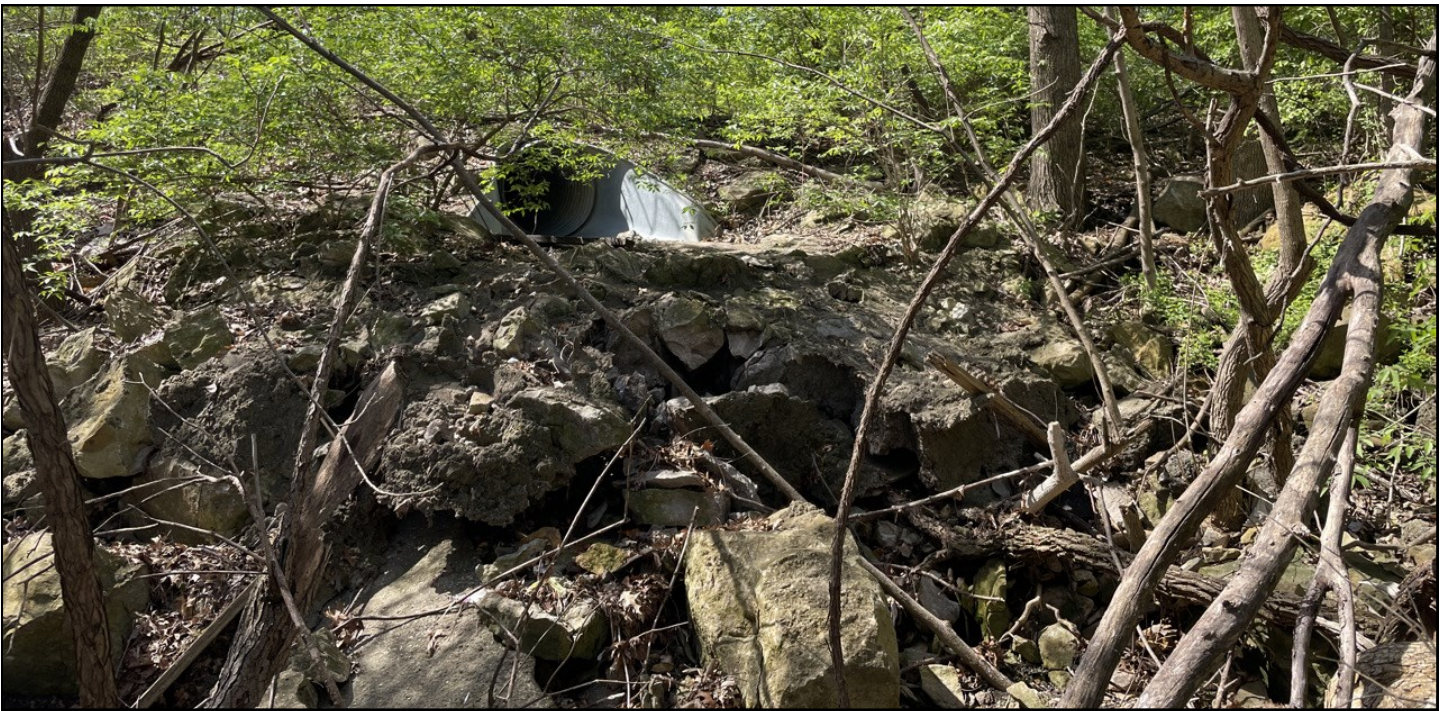
Photo No.	6	Photo Dir.	Southwest
-----------	---	------------	-----------

Description: Outlet for detention basin to the south of the property. Major erosion is present around the pipe outfall and grouted riprap is starting to undercut and fail.

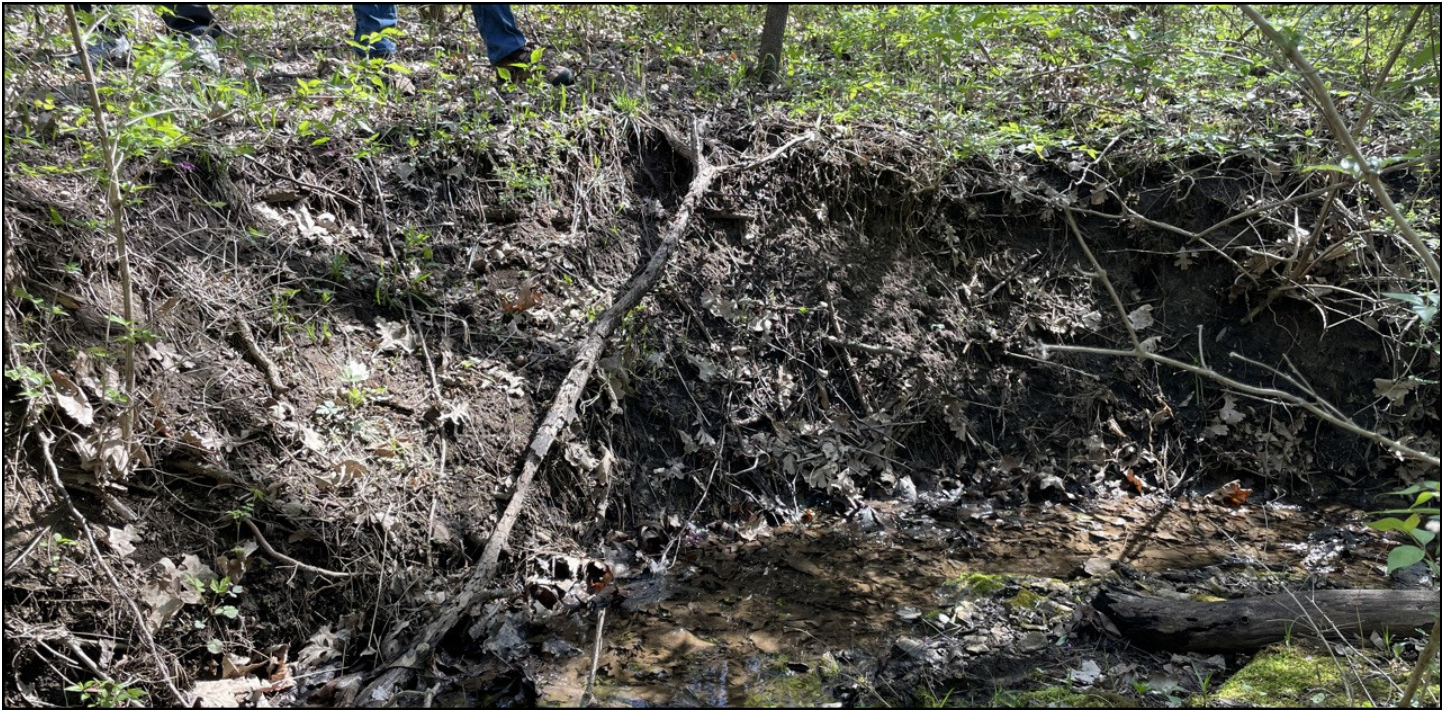
Photo No. 7

Description: Bank erosion present along east bank. Stream bank is approximately 4 feet tall.

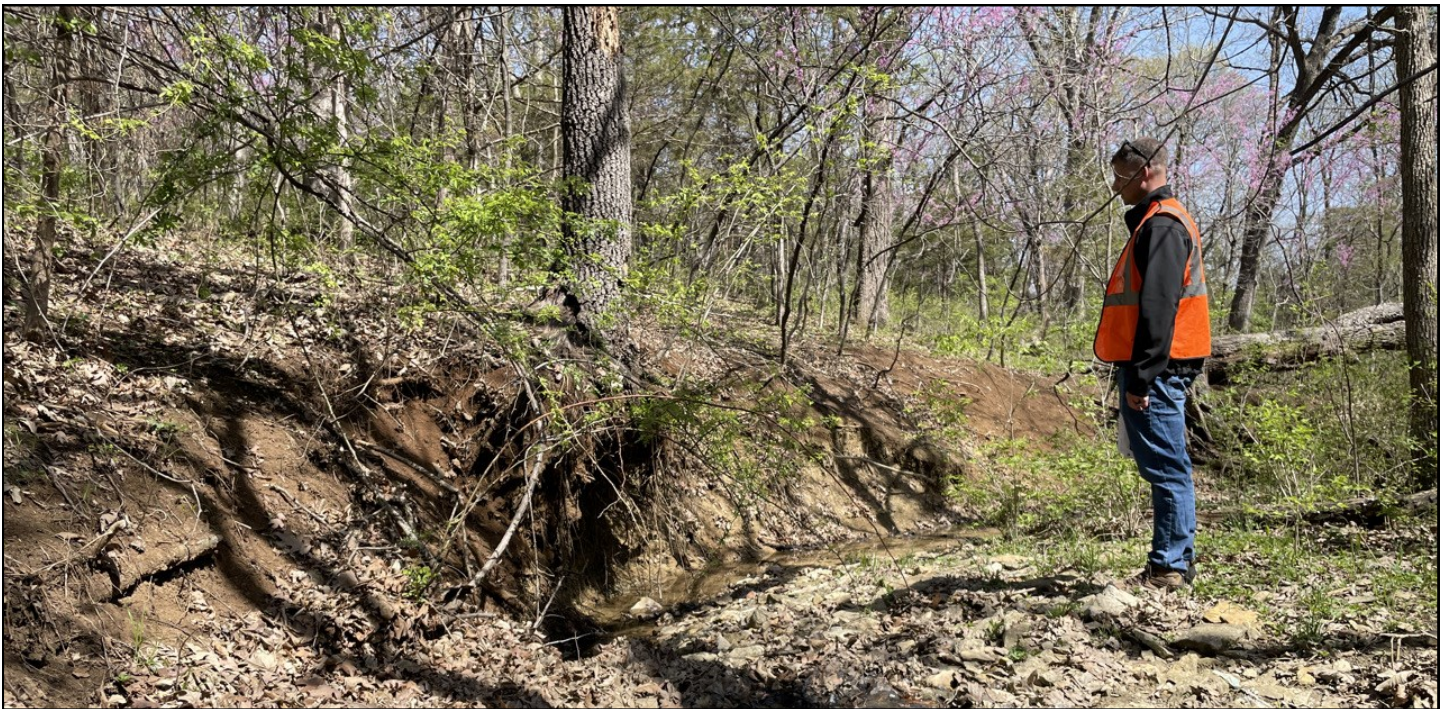
Photo No. 8

Description: Bank erosion present along outside bend of west bank. Exposed tree roots and loose dirt. Stream bank is approximately 4-5 feet tall.

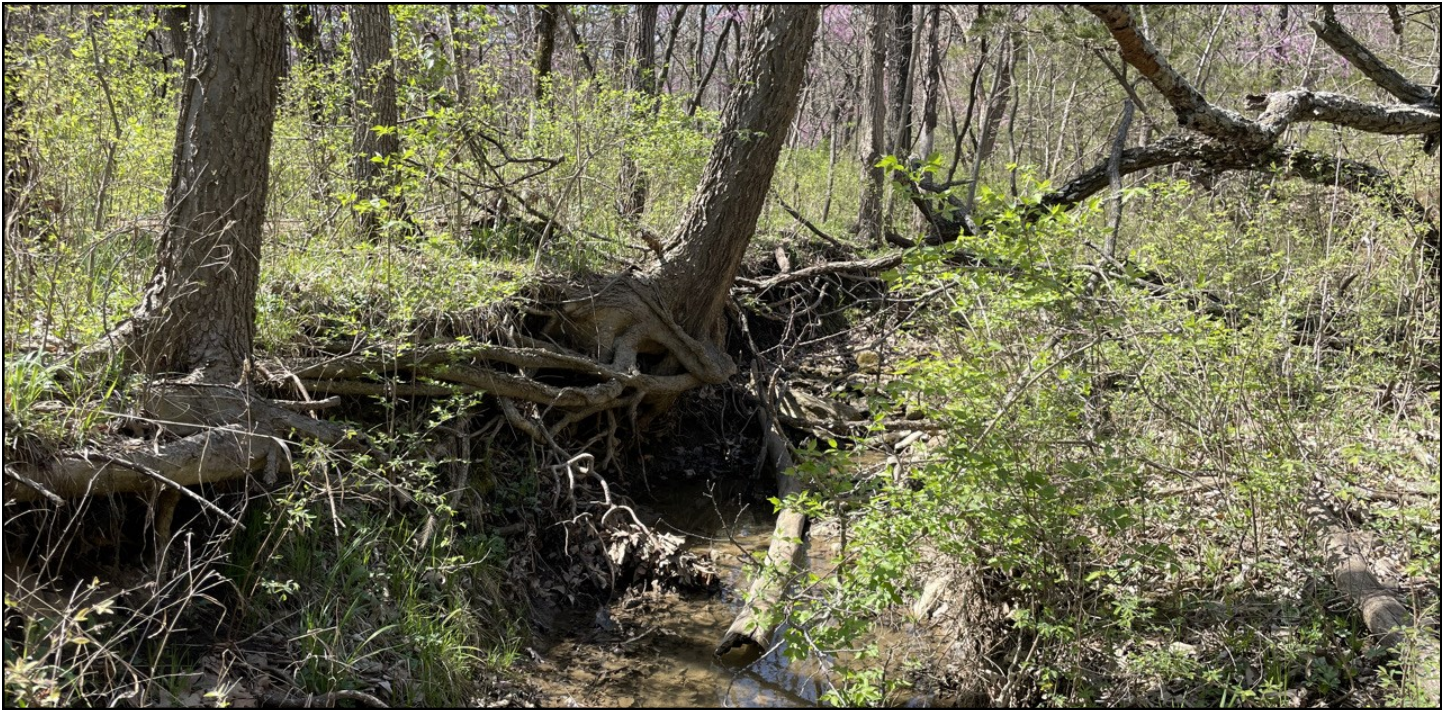
Photo No. 9

Description: Bank erosion present along east bank with exposed tree roots. Stream bank is approximately 4-5 feet tall.

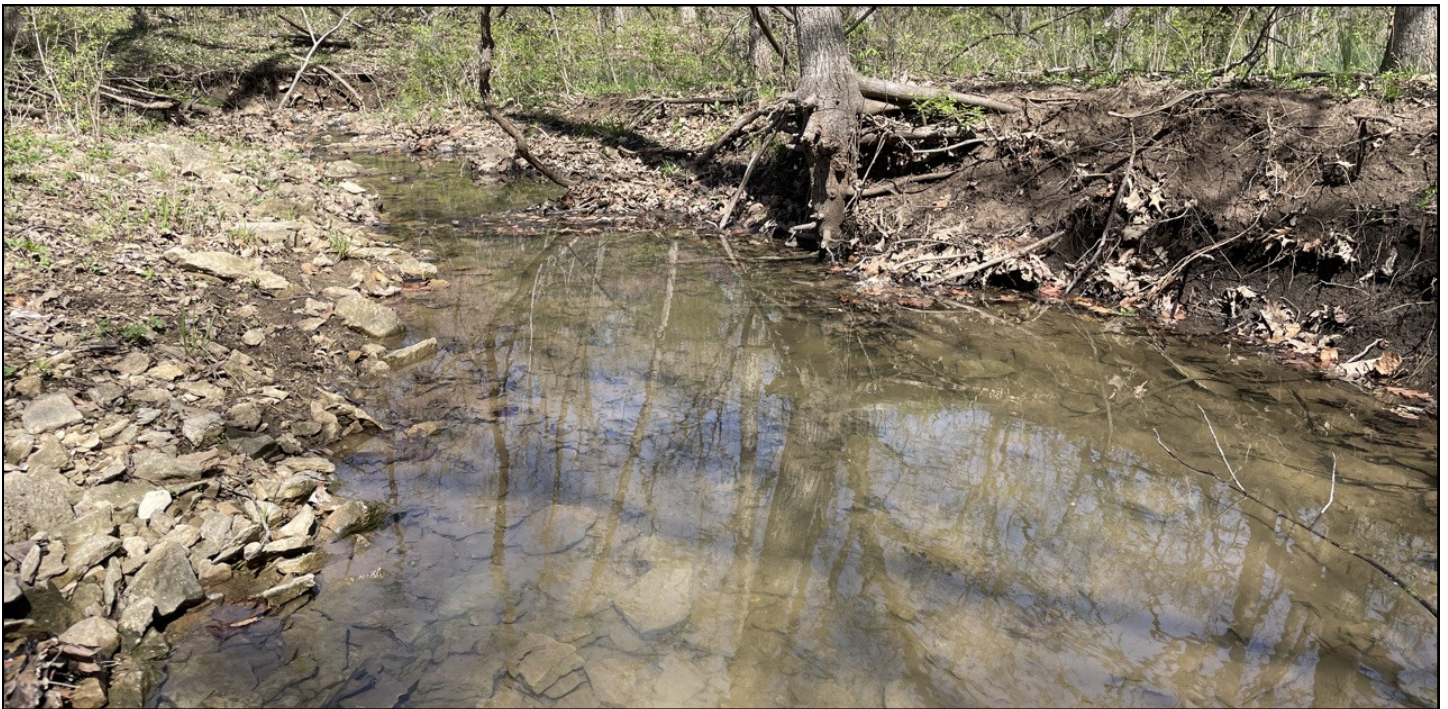
Photo No. 10

Description: Minor scour pool present with stream bank erosion along the east bank. Stream bank is approximately 3 feet tall. Stream bank erosion along west bank present approximately 25 feet downstream of pool. Bank erosion appears fairly new.

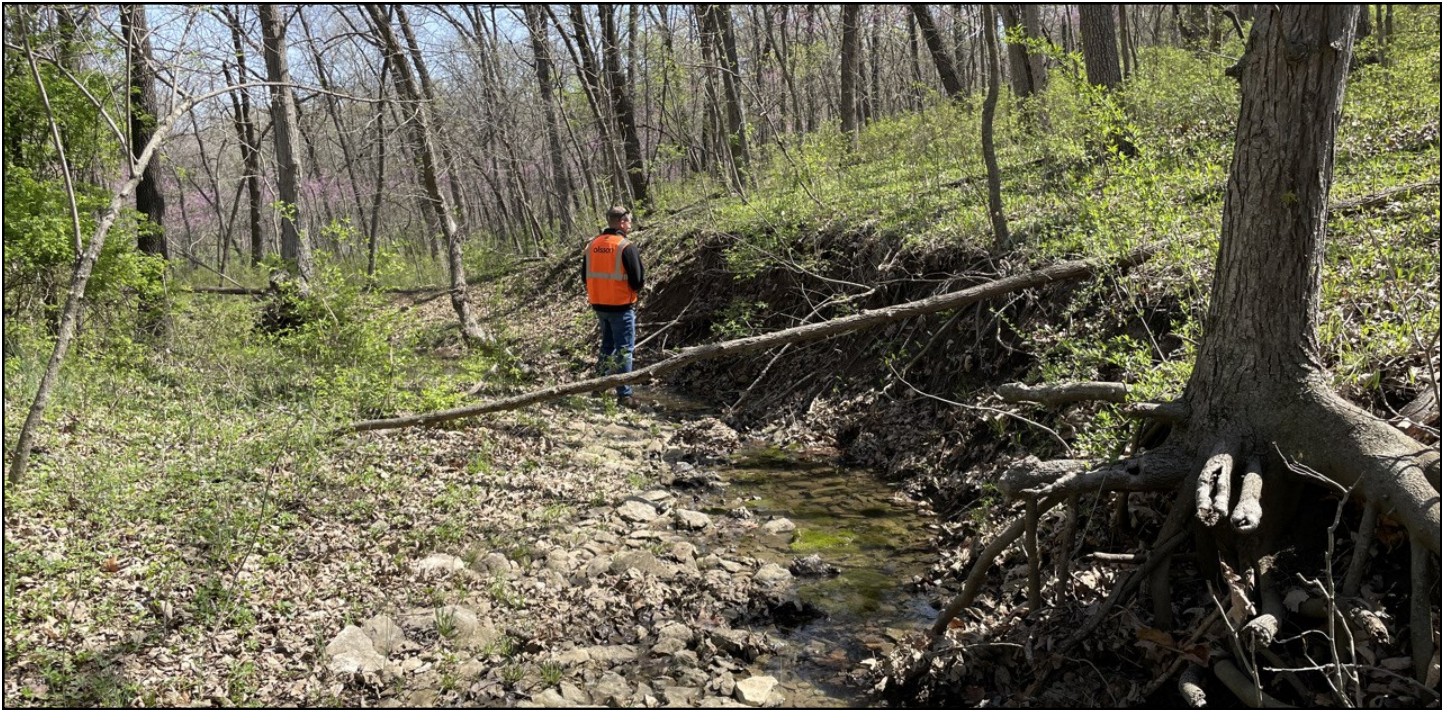
Photo No.	11	Photo Dir.	Northeast
-----------	----	------------	-----------

Description: Bank erosion present along east bank with exposed tree roots. Stream bank is approximately 5 feet tall.

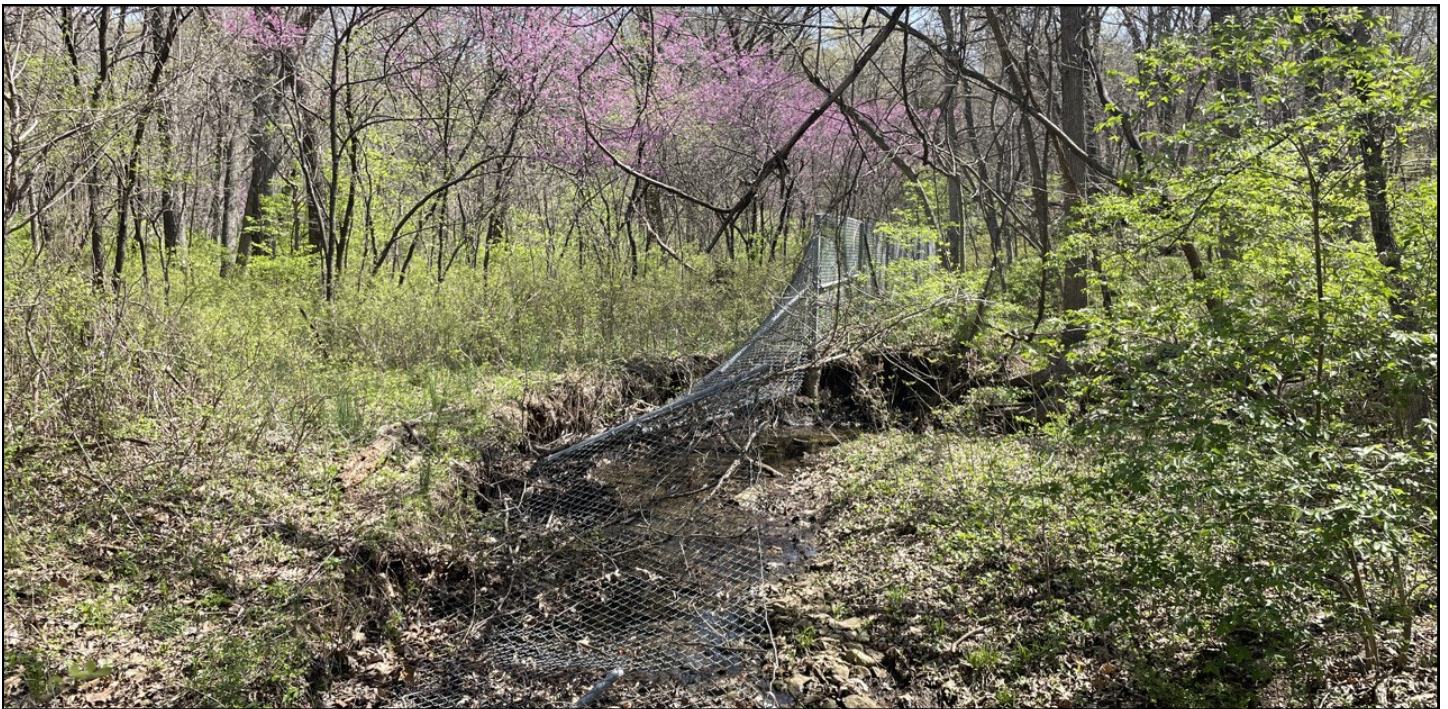
Photo No.	12	Photo Dir.	N/A
-----------	----	------------	-----

Description: Chain link fence along property line has fallen into stream due to erosion. Stream bank is approximately 2-3 feet tall.

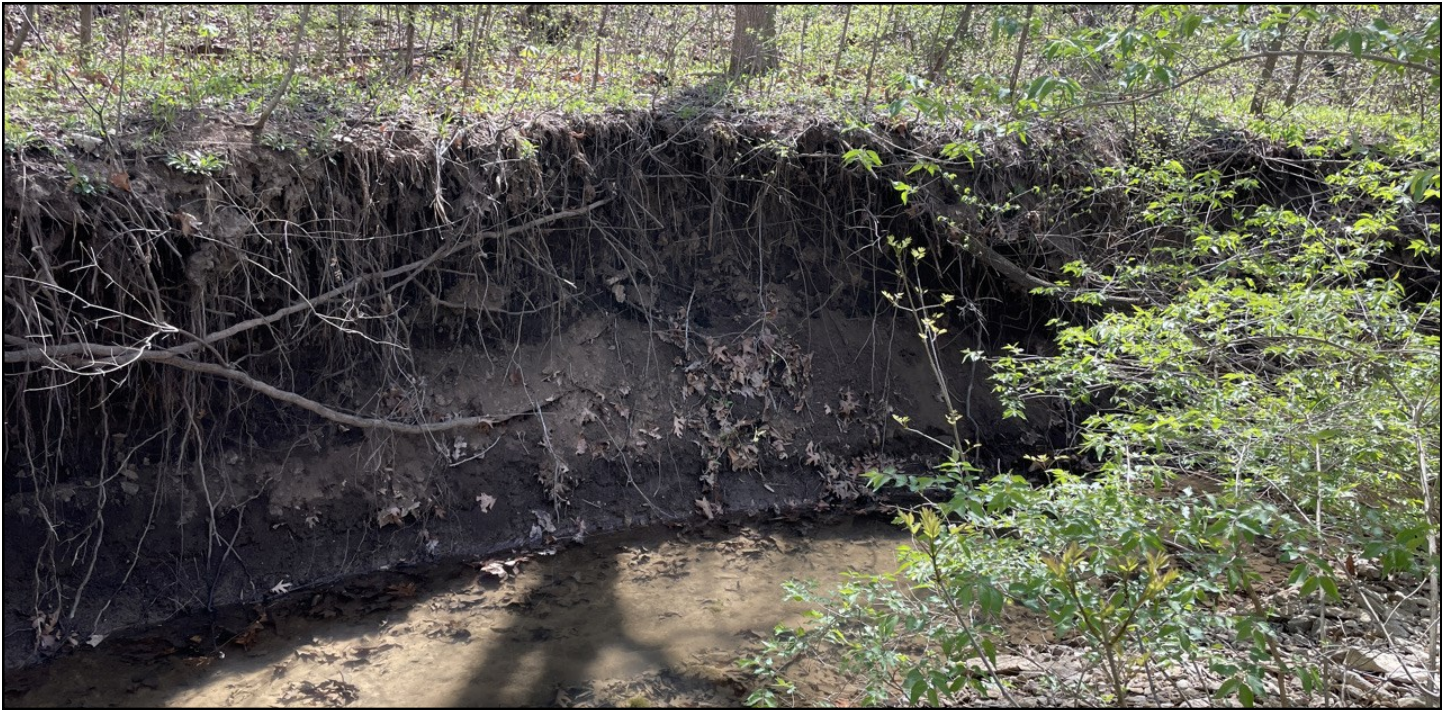
Description: Bank erosion present along east bank with many exposed roots. Stream bank is approximately 6-7 feet tall.

Streambank stabilization measures could be implemented near photo locations 13 (only if a sedimentation basin is not built), 14, and 16 to address the most severe streambank erosion that was identified in both the field walkthrough and the desktop analysis. There are generally two categories of effective streambank stabilization: hard stabilization and soft stabilization. Hard stabilization usually consists of placement of riprap to armor the bank from future erosion, and is typically more costly, but more reliable. Soft stabilization consists of mechanisms that increase vegetation or encourage the banks to “fill back in” naturally over time. This type of stabilization is usually less expensive and is typically considered more environmentally friendly, however is generally less reliable as it depends on the manipulation of natural processes, which are inherently more unpredictable.

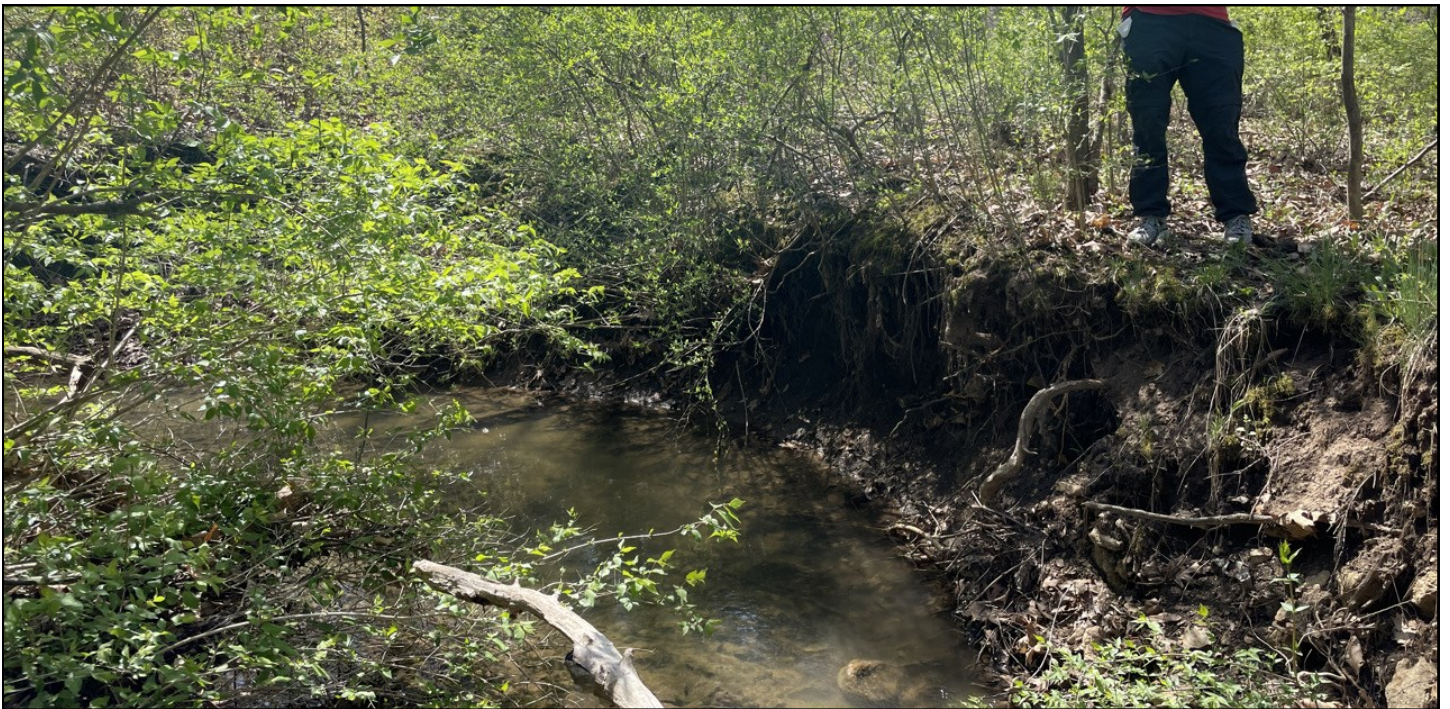
14

Description: Bank erosion present along west bank with exposed roots. Stream bank is approximately 4-5 feet tall.

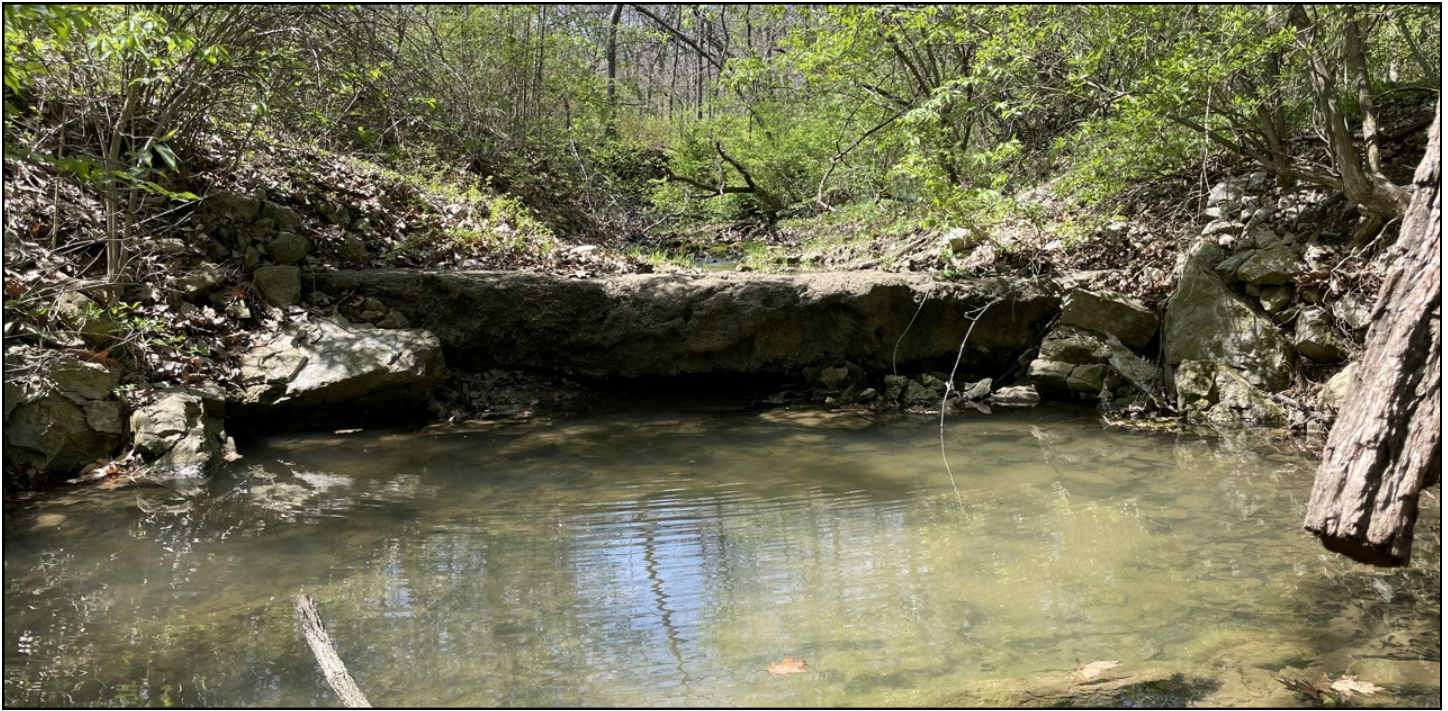
Photo No.	15	Photo Dir.	Southwest
-----------	----	------------	-----------

Description: Sanitary sewer pipe encasement crossing the stream. Water is undercutting on the upstream side of the encasement and flowing downstream.

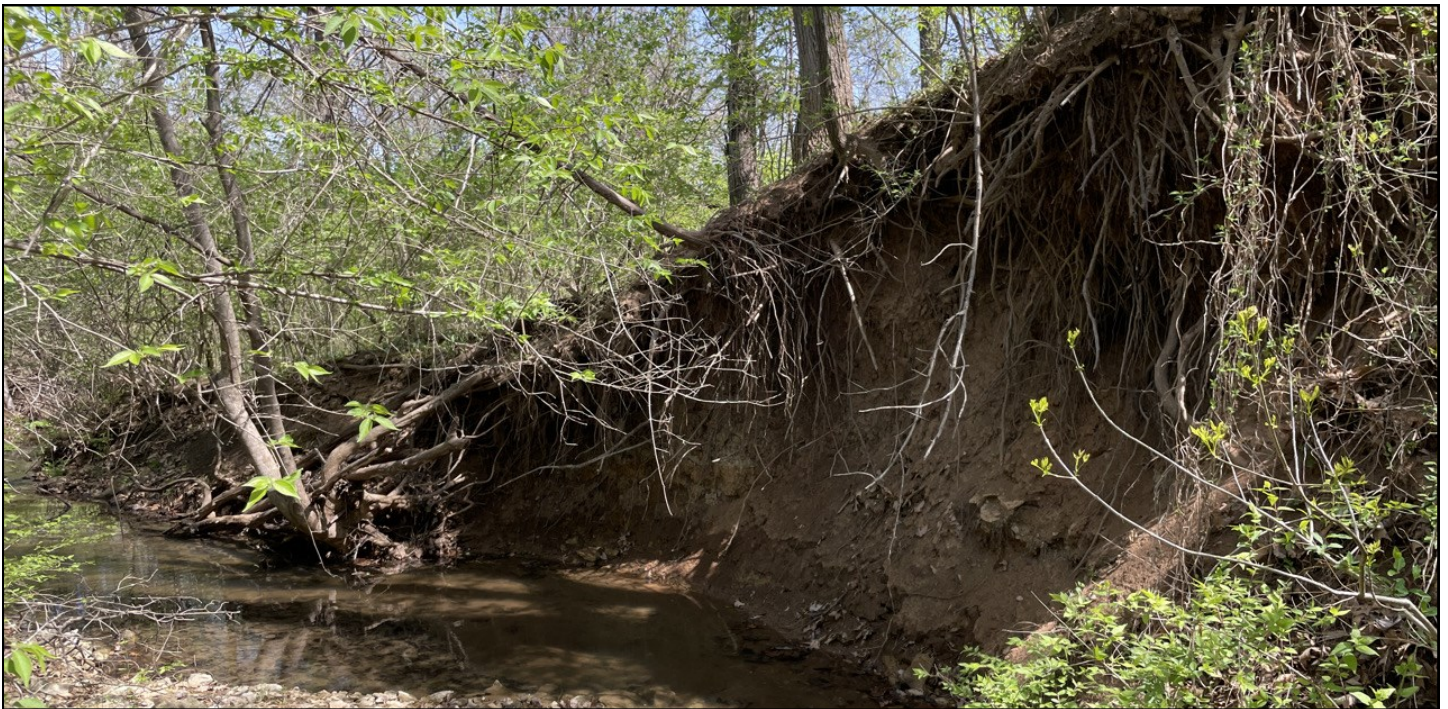
Photo No.	16	Photo Dir.	Northeast
-----------	----	------------	-----------

Description: Significant bank erosion present along east bank with many exposed roots. Located just downstream of sanitary sewer crossing. Stream bank is approximately 20 feet tall.

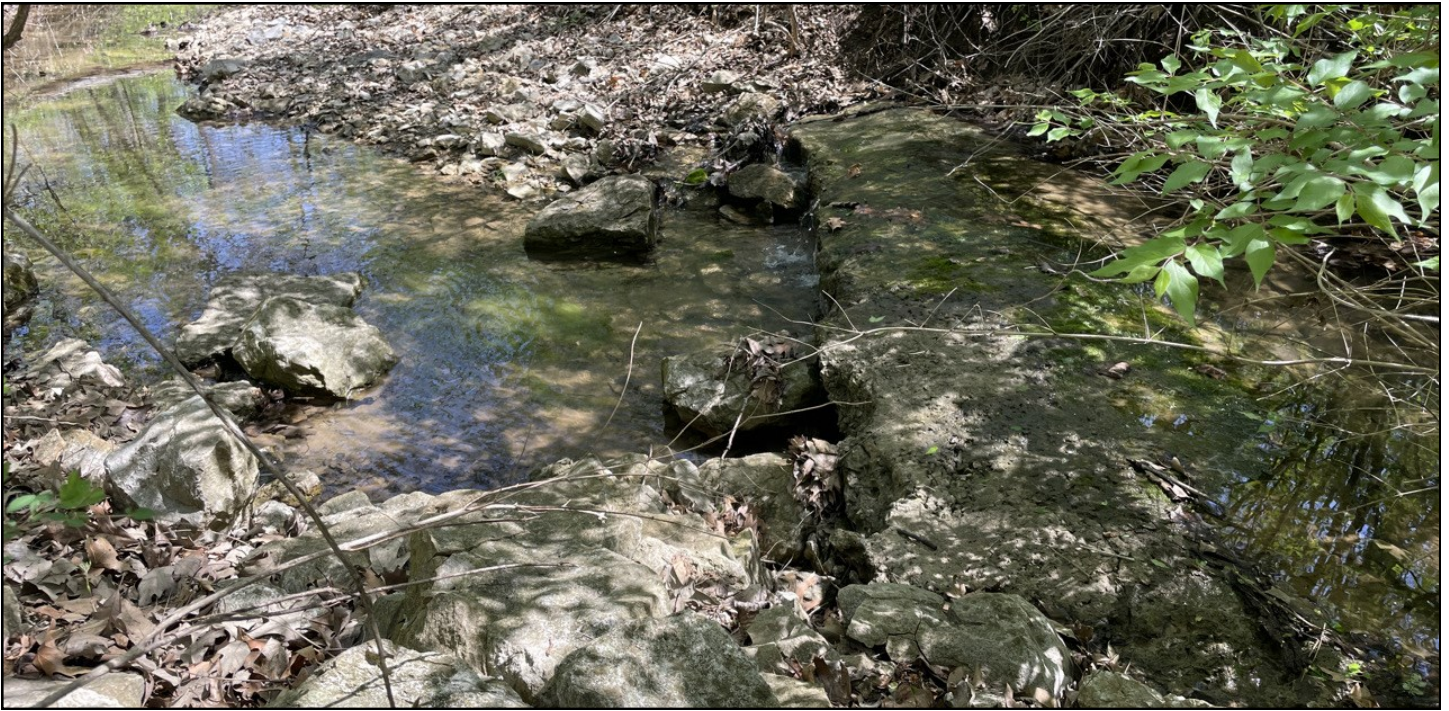
Photo No. 17

Description: Second sanitary sewer pipe encasement crossing.
