MEMO

To:	City of Lake Quivira Attn: Angela Gupta 10 Crescent Boulevard Lake Quivira, KS 66217
From:	Brent Johnson, PE Brian Fairchild, PE, CFM Ethan Price, EIT
RE:	5535 Renner Road Sediment Analysis & Field Walkthrough
Date:	May 15, 2023
Project #:	023-00917
Phase:	200
Task:	001

**Lake Quivira
Erosion Analysis Site Visit
Photo Locations and Desktop Analysis**

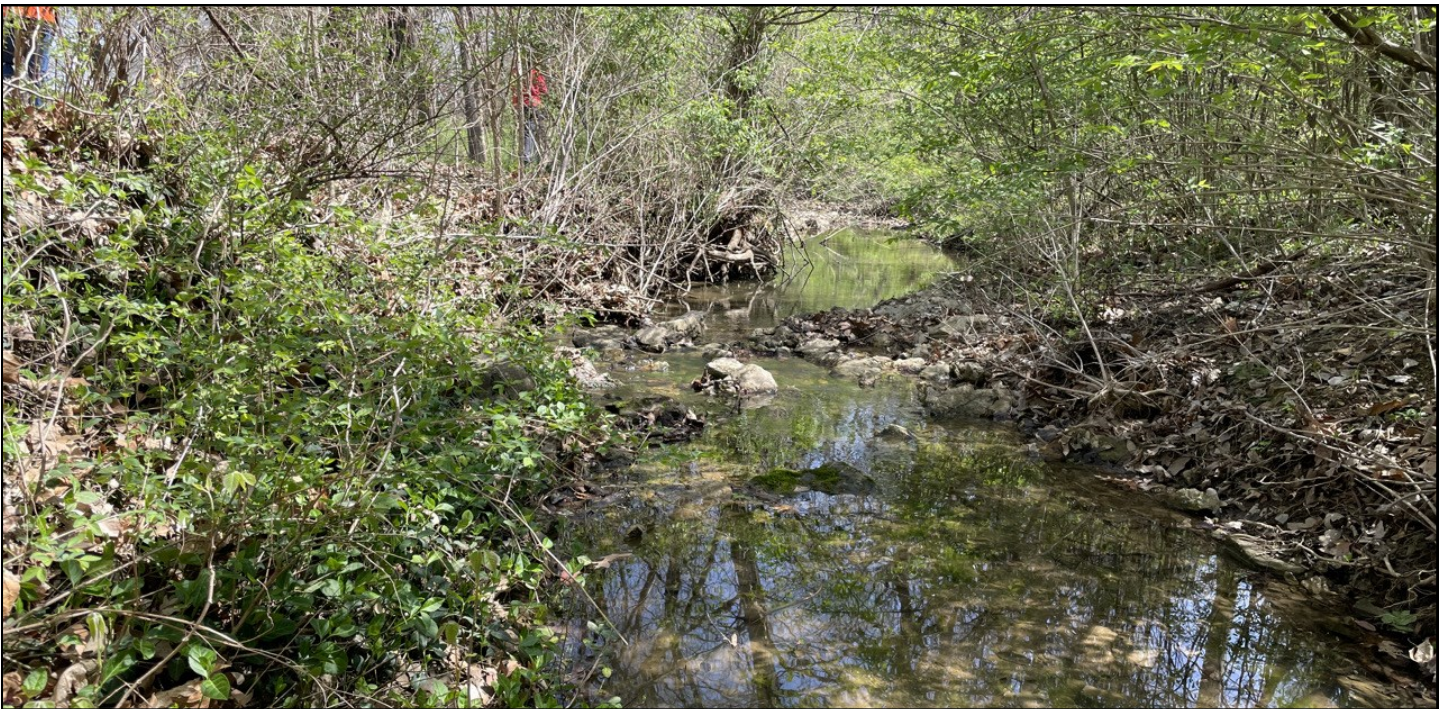
Photo No. 18

Description: Minimal amounts of stream bank erosion on the downstream end of the stream, as it begins to run between residential properties.
